BANK STABILITY ANALYSIS FOR THE UPPER MISSOURI RIVER

STEPHEN E DARBY and COLIN R THORNE

UNIVERSITY OF NOTTINGHAM
UK

AUGUST 1996

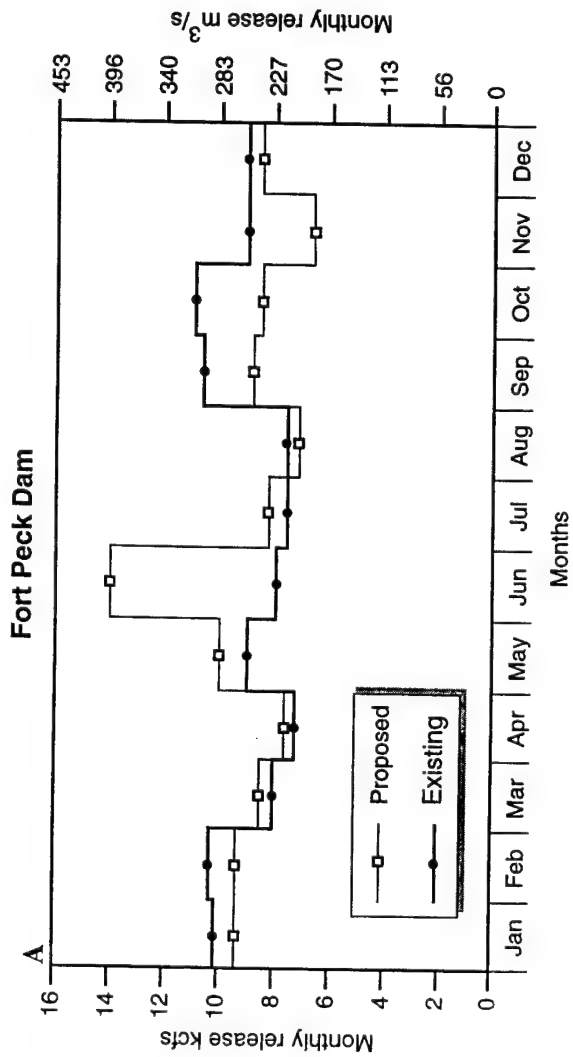
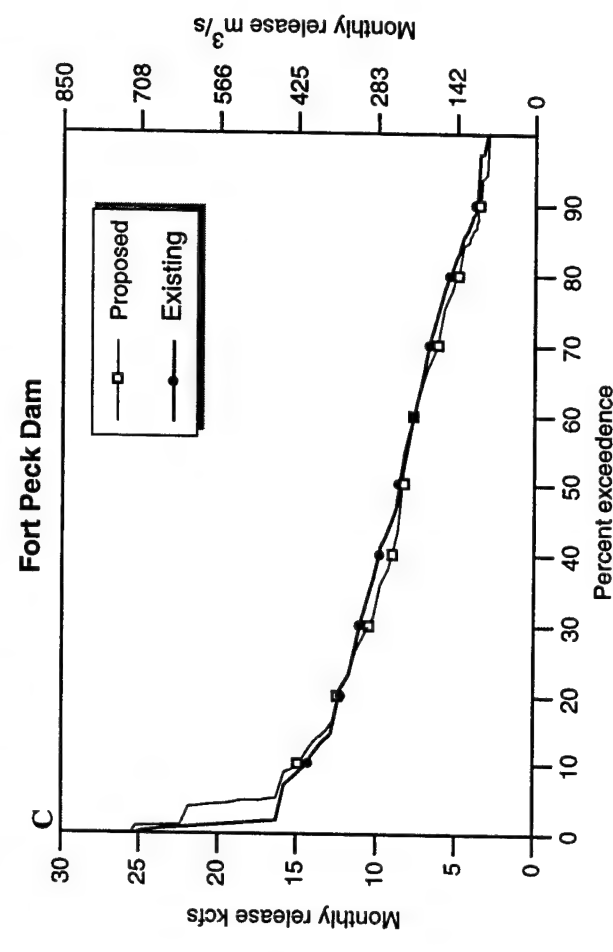
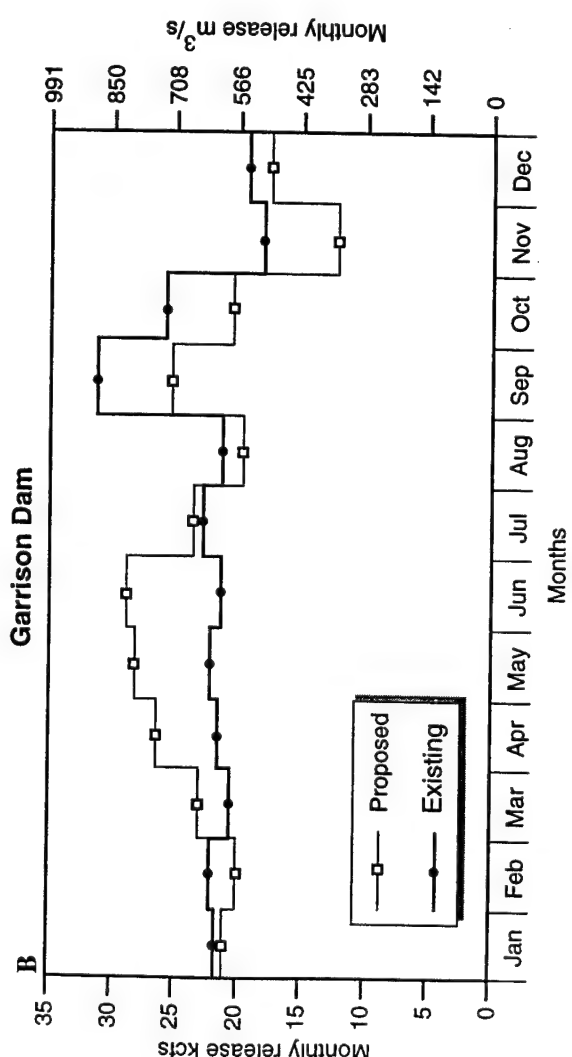
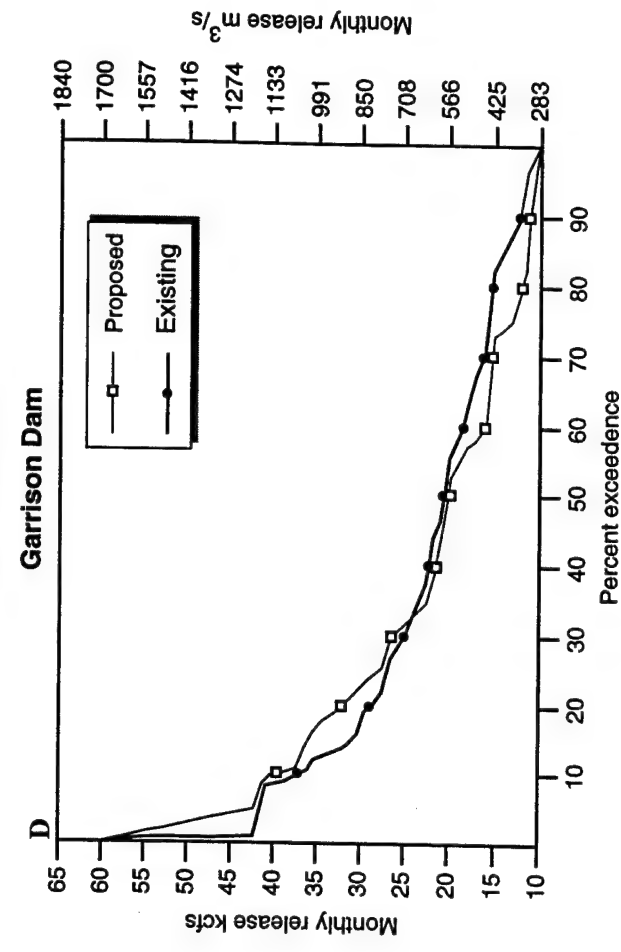
FIGURE 2

Figure 2. Comparison of proposed and existing flow regimes: (A) Proposed and existing annual hydrographs, Fort Peck dam; (B) Proposed and existing annual hydrographs, Garrison dam; (C) Proposed and existing flow duration curves, Fort Peck dam; (D) Proposed and existing flow duration curves, Garrison dam. Note that proposed and existing hydrographs are planned discharge releases. In fact, actual releases (existing flow regime) during the period of record have been modified according to catchment hydrological conditions, and have diverged markedly during periods when runoff rates were significantly above or below average. In contrast, the flow duration curve for the existing flow regime is based on the actual record of flows.

Changes in the operation of Fort Peck and Garrison Dams on the Upper Missouri River in Montana and North Dakota (Figure 1) have been proposed as a means to protect fisheries and wildlife interests, while continuing to fulfill essential flood-water storage and hydropower functions. The action agency responsible for river management and engineering (United States Army Corps of Engineers (COE)) is interested in predicting whether or not these operational changes might cause discernible impacts on bank erosion processes, bank stability with respect to mass failure, and rates of bankline migration. Annual hydrographs and flow duration curves for the existing and proposed operating regimes of Fort Peck and Garrison dams are shown in Figure 2. The proposed flow regime would have the effect of increasing discharge releases during spring and summer months, but decreasing discharge at other times (Figures 2a and 2b). Peak discharge will be increased from approximately $310 \text{ m}^3/\text{s}$ to $400 \text{ m}^3/\text{s}$ in the Fort Peck dam reach, but will be decreased from approximately $890 \text{ m}^3/\text{s}$ to $840 \text{ m}^3/\text{s}$ in the Garrison dam reach. In both reaches, existing baseflows will be reduced under the proposed operating schemes and the overall impact of proposed changes in dam operation will be to increase flow duration for relatively large magnitude flows and reduce flow duration for lower magnitude flows (Figures 2c and 2d).

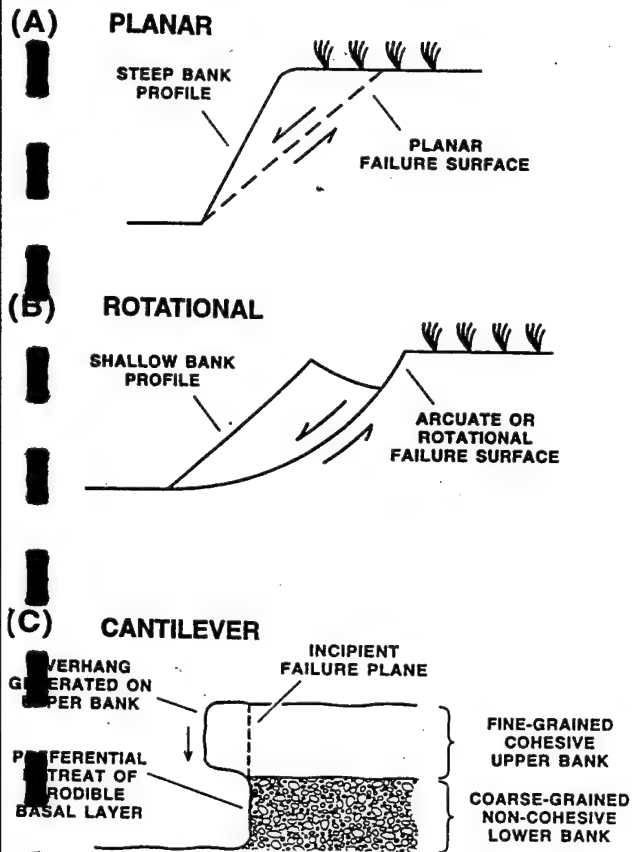
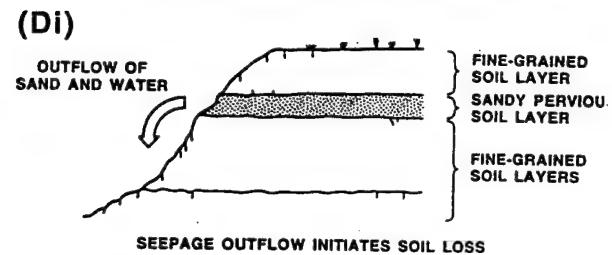
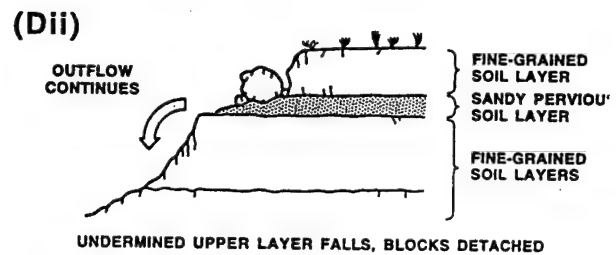
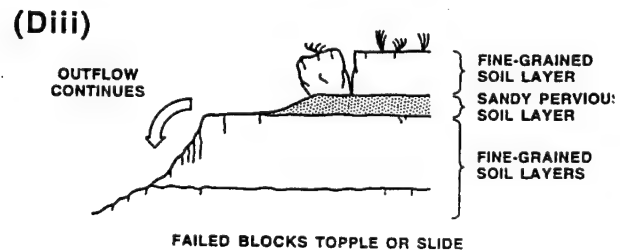
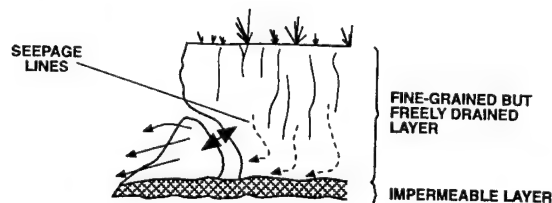
FIGURE 3

Figure 3. Bank failure mechanisms observed during field reconnaissance: (A) Planar failure; (B) Rotational failure; (C) Cantilever failure; (D) Sequence of events in Piping/Sapping type failures; (E) Pop-out failure

A stream reconnaissance was made by boat in accordance with guidelines documented by Thorne (1993). Approximately 160 miles of bank (62% of the study reaches) were classified according to stratigraphy, profile, failure mechanism, and overall stability. Bank-failure mechanisms were classified as being of the planar, rotational, cantilever, piping/sapping, or

pop-out type (Figure 3). Failure mechanisms were recorded on 1:24000 scale aerial photographs as the boat progressed downstream, and later used to estimate the locations and percentage lengths of stable and unstable banks, and the proportion of unstable bankline in each failure category. Notes were made regarding the geomorphic context of bank retreat at each location and, particularly, how failure categories related to position at channel bends. Photographs were taken at a total of 126 sites along the two study reaches. Examples of these photographs are shown in Plate 1.

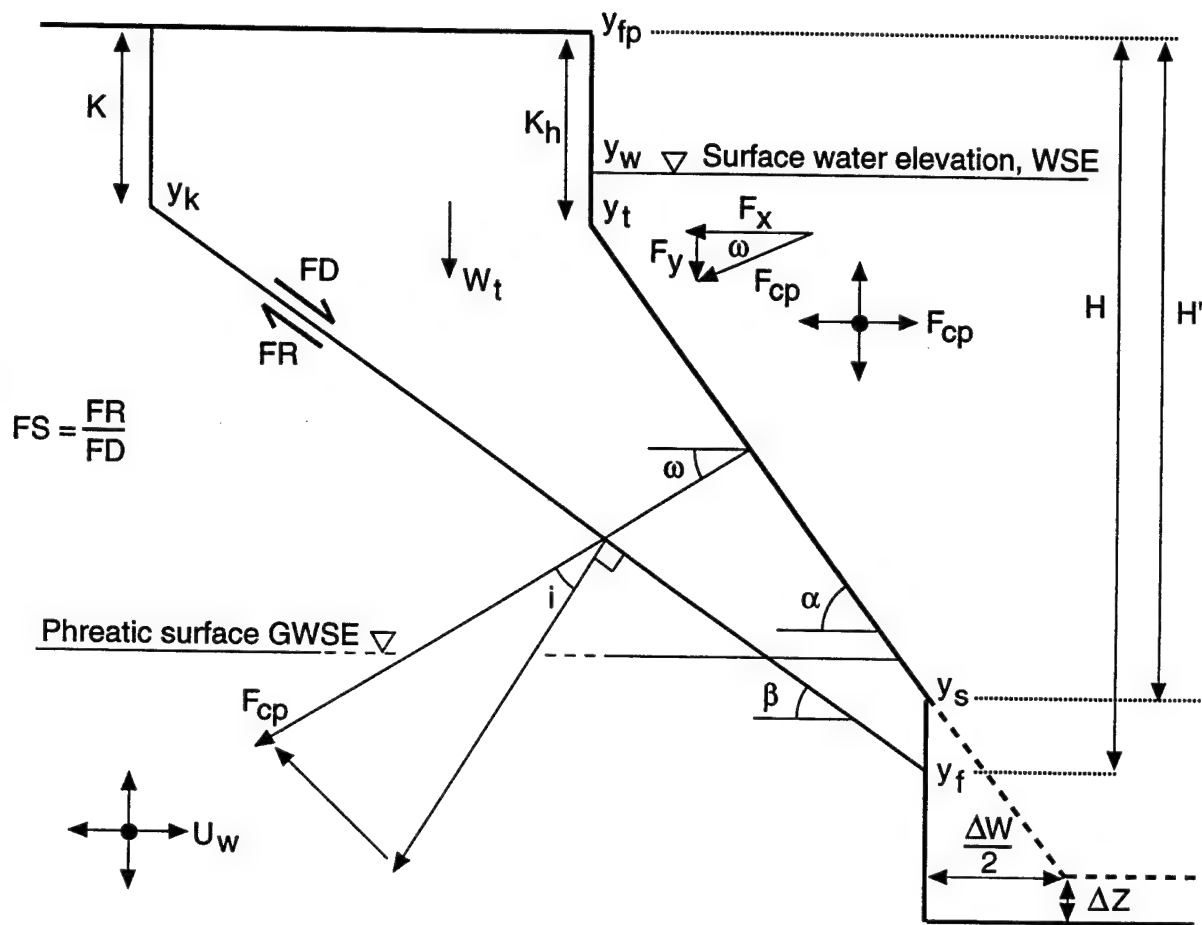
FIGURE 4

Figure 4. Definition diagram for the Darby-Thorne bank stability analysis (from Darby and Thorne, 1996). Symbols: K = tension crack depth, K_h = relic tension crack depth, i = uneroded bank angle, β = failure plane angle, U_w = pore pressure, F_{cp} = hydrostatic confining pressure, ω = angle between uneroded bank profile and resultant of hydrostatic confining pressure, α = angle between resultant of hydrostatic confining pressure and normal to failure plane, GWSE = ground water surface elevation, WSE = y_w = surface water elevation, W_t = weight of failure block, FD = driving force, FR = resisting force, y_b = floodplain elevation, y_t = elevation of base of relic tension crack, y_s = elevation of base of uneroded bank slope, y_f = elevation of base of failure plane, y_k = elevation of base of tension crack, ΔZ = amount of near-bank bed scour, $\Delta W/2$ = amount of fluvial bank erosion

The riverbank stability analysis developed and tested by Darby and Thorne (1996) is suitable for use in this study. Simulations are based on bank profiles deformed by combinations of near-bank bed scour and direct fluvial entrainment (Figure 4). Upper bank failures can also be simulated, and the effects of pore water and hydrostatic confining pressures are included in the analysis. The analysis has also been shown to have better predictive ability than the alternative models of Lohnes and Handy (1968), Huang (1983), or Osman and Thorne (1988) (Darby and Thorne, 1996; see Table 2). The analysis is valid for cohesive, steep (bank angles greater than 50 degrees), eroding, non-layered riverbanks which fail along planar failure surfaces. Based on the results of field reconnaissance, this failure is the type most commonly observed along the study reaches (see Table 8 and Figure 9).

To apply the analysis, bank height, tension crack depth, relic tension crack depth and angle of the uneroded bank slope are required to describe the geometry of the bank profile (Figure 4). Cohesion, friction angle and unit-weight values are used to characterize geotechnical soil properties. Ground water and surface water elevations are used to simulate the effects of bank hydrology on stability. Input data parameters corresponding to bank

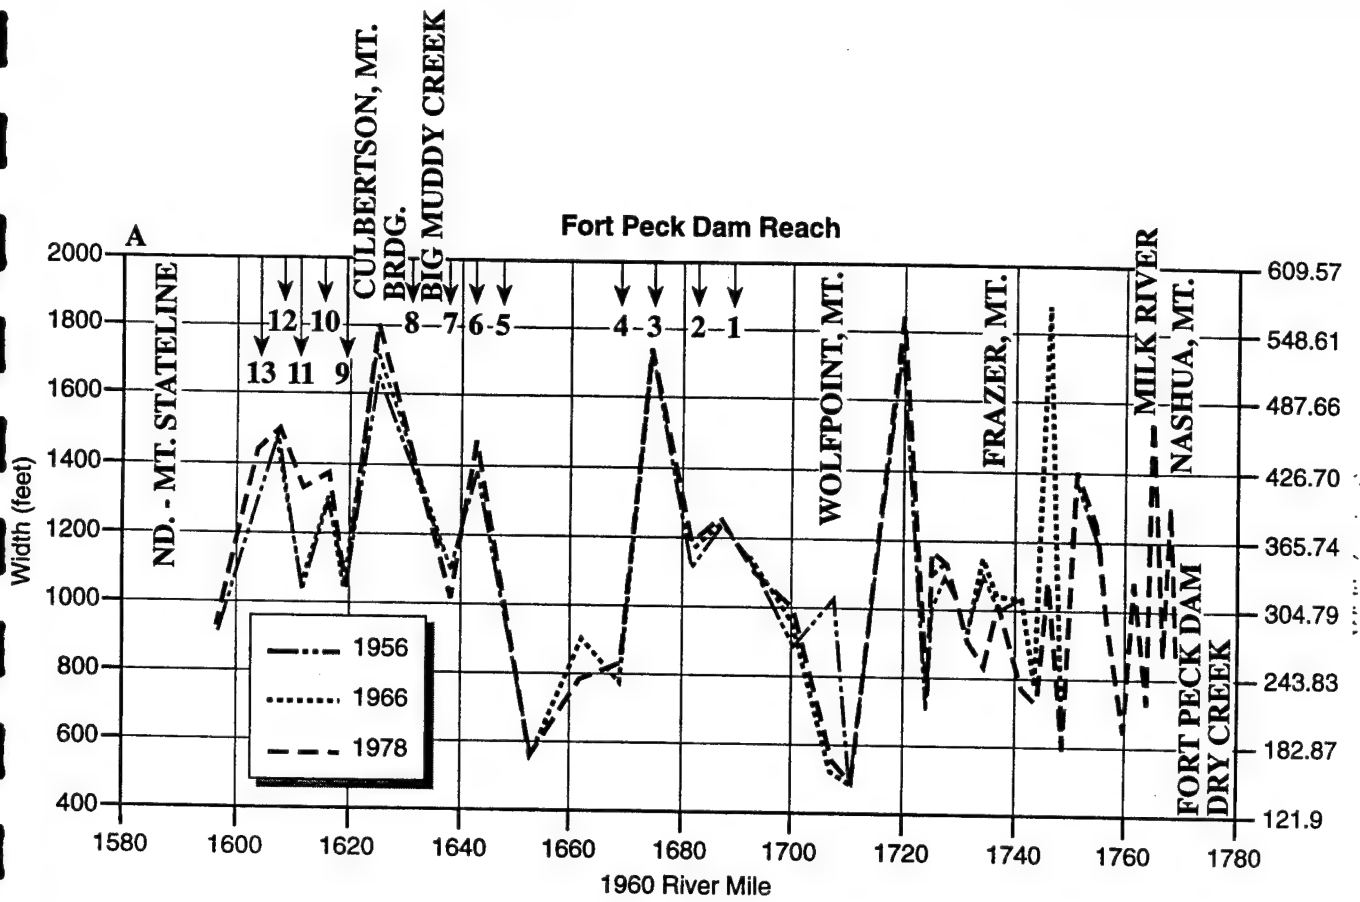
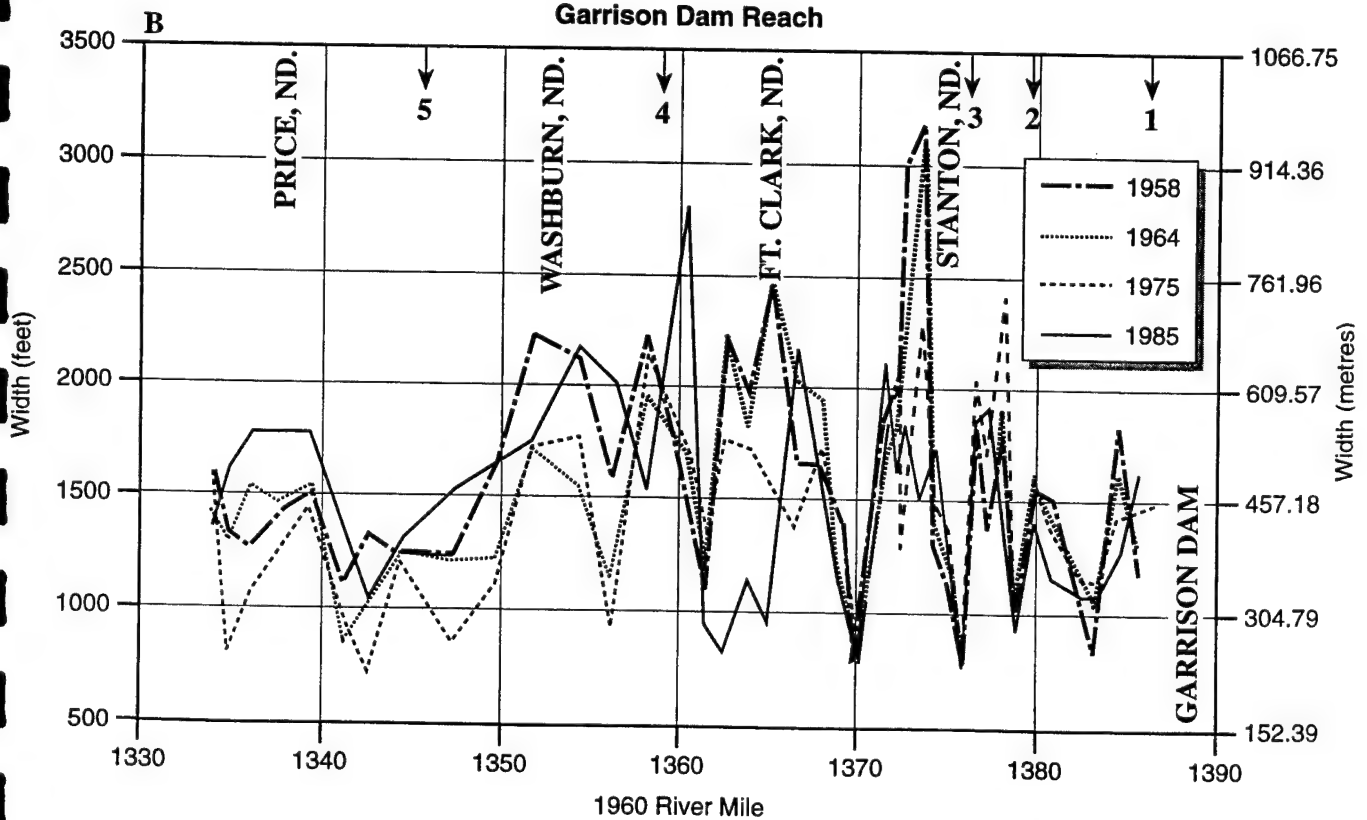
FIGURE 6

Figure 6. Channel-bed width versus time for: (A) Fort Peck dam study reach; (B) Garrison dam study reach (from MRD, 1994). Locations of bank stability analysis study sites are also indicated

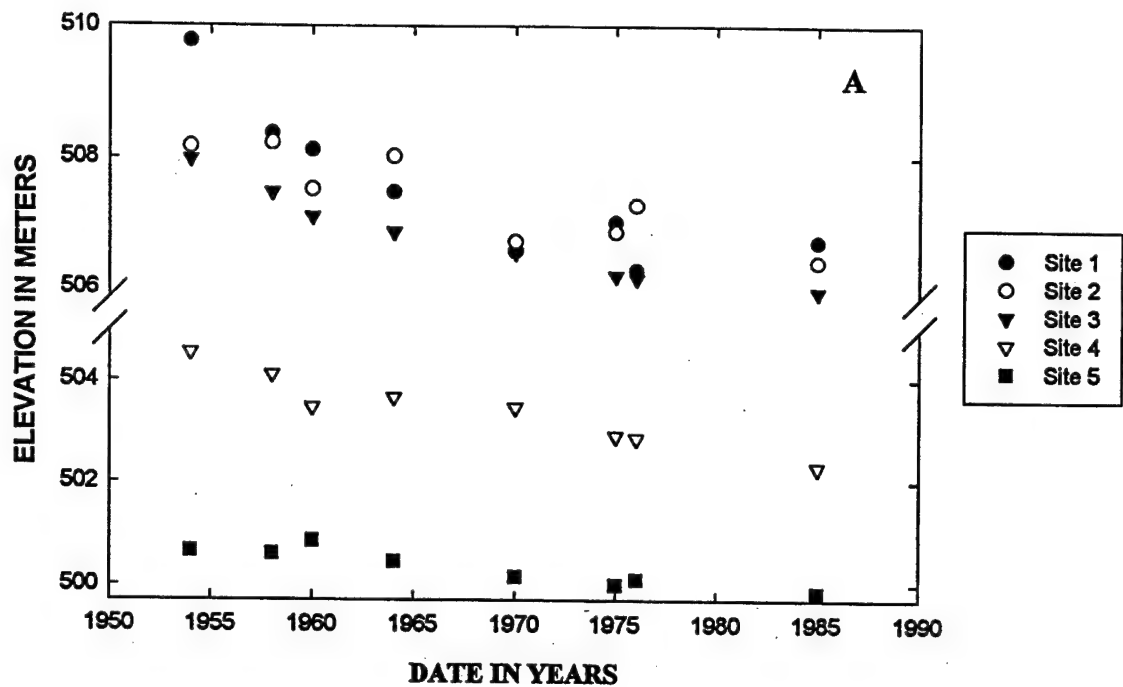
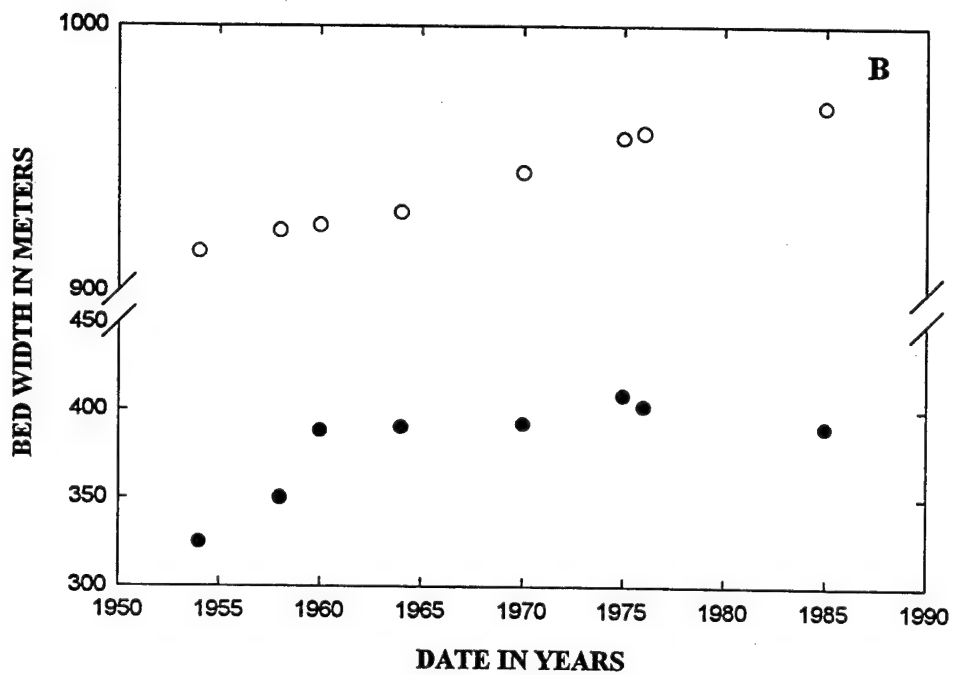
FIGURE 7

Exponential and logarithmic regression curves were fitted to the data so obtained. Examples are shown in Figure 7. The regression relationship that most closely fitted the survey data (highest r^2 value) was selected for use in extrapolating future channel response to the regulated flow regime. Estimates of cumulative amounts of near-bank bed degradation (ΔZ) and bank-toe erosion ($\Delta W/2$) compared to estimated channel-bed conditions at the present time (1995) projected 1 (1996), 5 (2000), 10 (2005), 20 (2015) and 50 (2045) years into the future (Table 5) were obtained by extrapolation of the empirical regression curves listed in Table 4. It is stressed that the 1995 reference values of mean bed elevation and bed width are themselves extrapolated estimates, since the dates of the last surveys used to construct the regression curves are 1978 and 1985, for the Fort Peck and Garrison dam reaches, respectively.

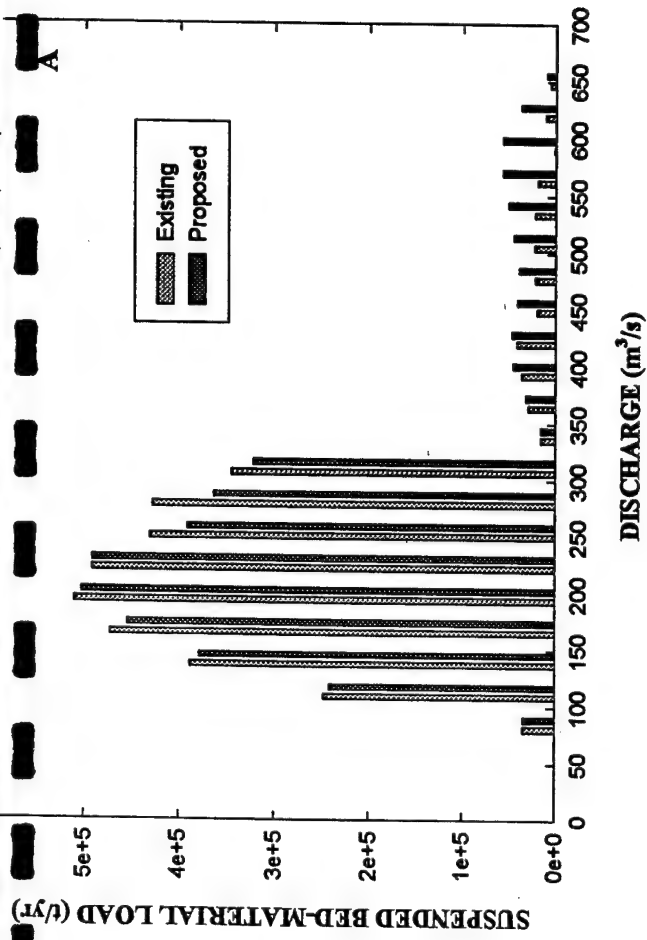
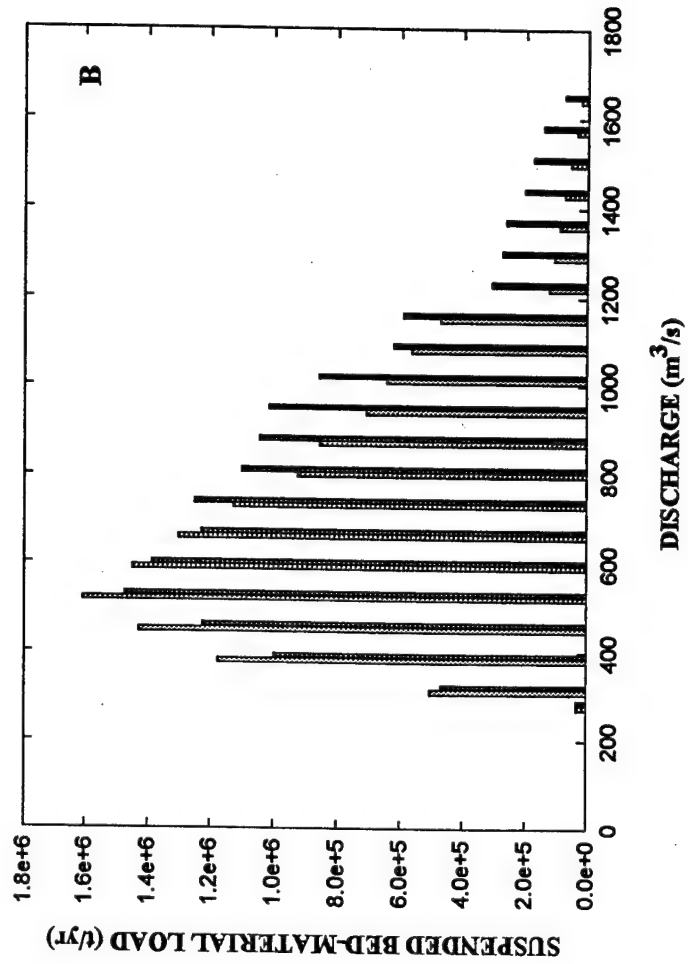
FIGURE 8

Figure 8. Estimated suspended bed-material load by discharge class for proposed and existing flow regimes for: (A) Fort Peck dam study reach; (B) Garrison dam study reach. Based on flow duration curves shown in Figures 2c and 2d, and bed-material load rating curves summarized in equations (2) and (3)

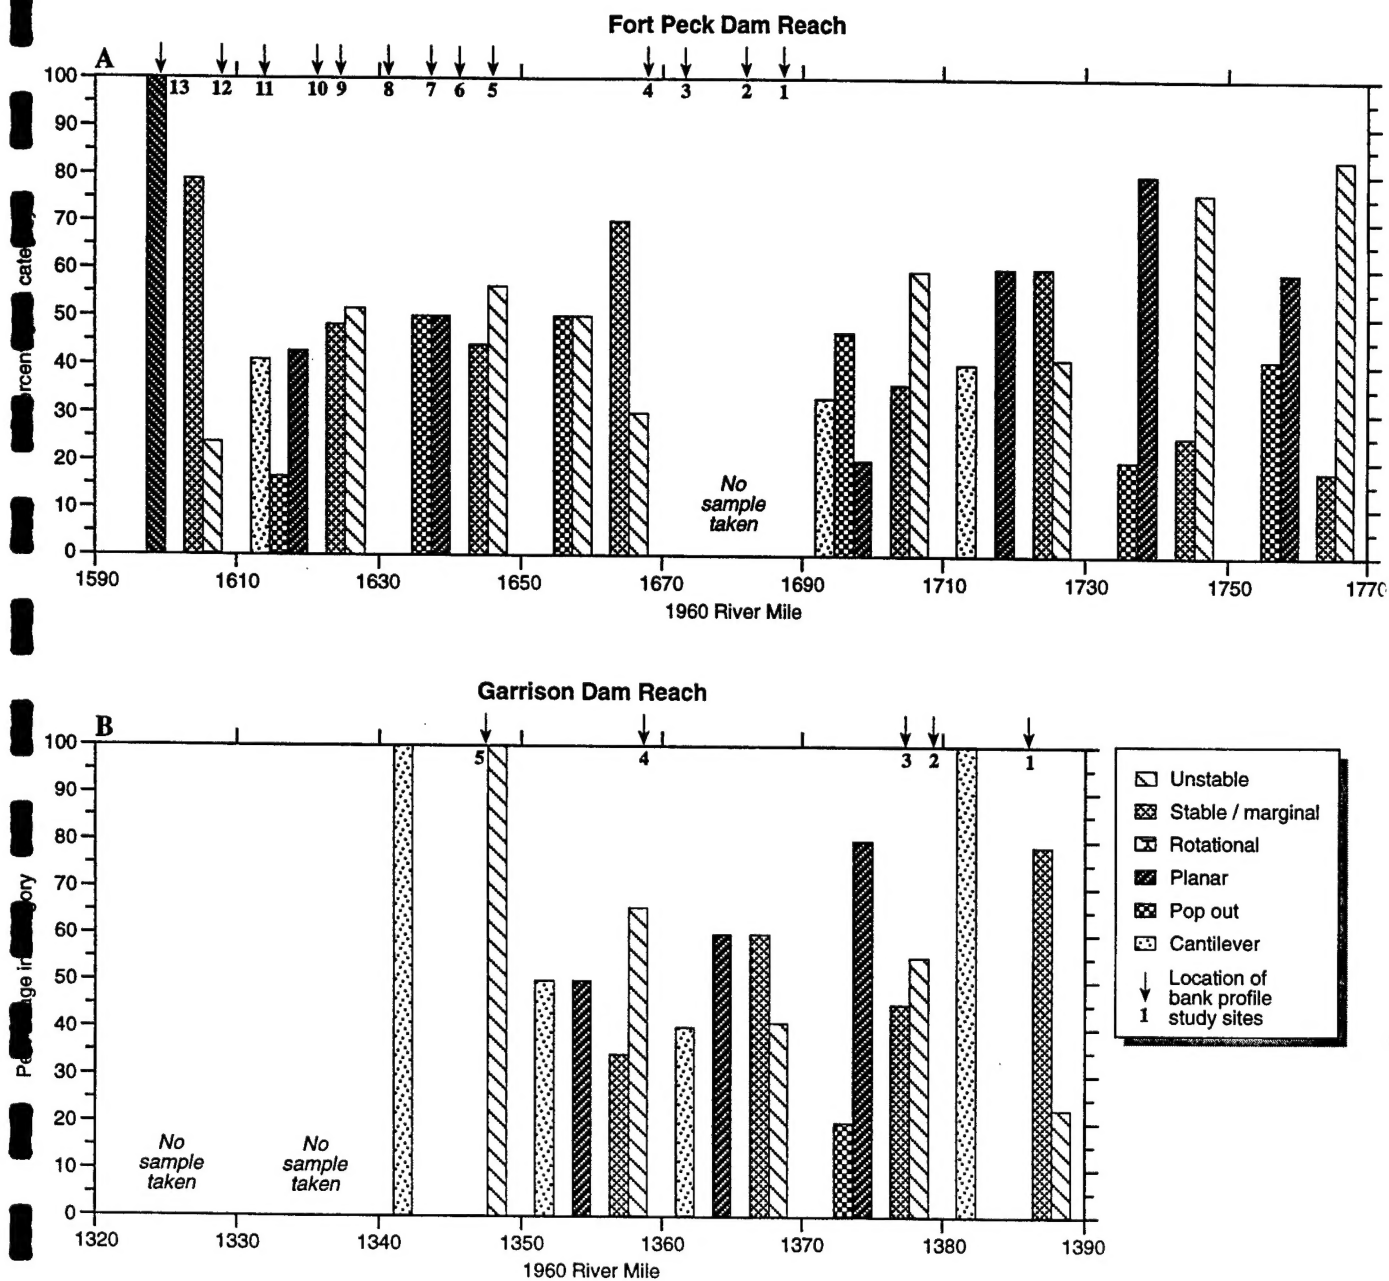
FIGURE 9

Figure 9. Classification of observed contemporary (1995) bankline stability conditions by location along: (A) Fort Peck dam study reach; (B) Garrison dam study reach. "No sample taken" indicates reaches where no field reconnaissance was made

Contemporary conditions of bankline stability are summarized in Figure 9 and Table 8. 57% of the banks reconnoitered in the Fort Peck dam reach display evidence of instability with respect to mass instability, compared to 41% in the Garrison dam reach. Planar failures are the most common mode of collapse, accounting for 45% and 59% of unstable banks in the Fort Peck and Garrison dam reaches, respectively. Popout (33% Fort Peck dam reach, 14% Garrison dam reach) and cantilever-type (19% Fort Peck dam reach, 27% Garrison dam reach) failures are also observed along shorter, but still significant, lengths of unstable bankline in both reaches.

Figure 9a shows a general tendency for the severity of bank instability observed during September 1995 to increase with distance downstream of Fort Peck dam. In contrast, bank instability decreases with distance downstream of Garrison dam (Figure 9b). Figure 9 shows

that the only systematic change in failure mechanism versus distance downstream is a relative increase in the frequency of cantilever failures in the Fort Peck dam reach (Figure 9a). Planar failures are the most common mechanism of bank collapse in this reach (with the exception of sub-reaches between RM 1750-1730 and RM 1710-1690). Planar failures are dominant in three of five sampled sub-reaches of the Garrison dam reach, although classifications are based on a relatively small sample size in the other two sub-reaches.

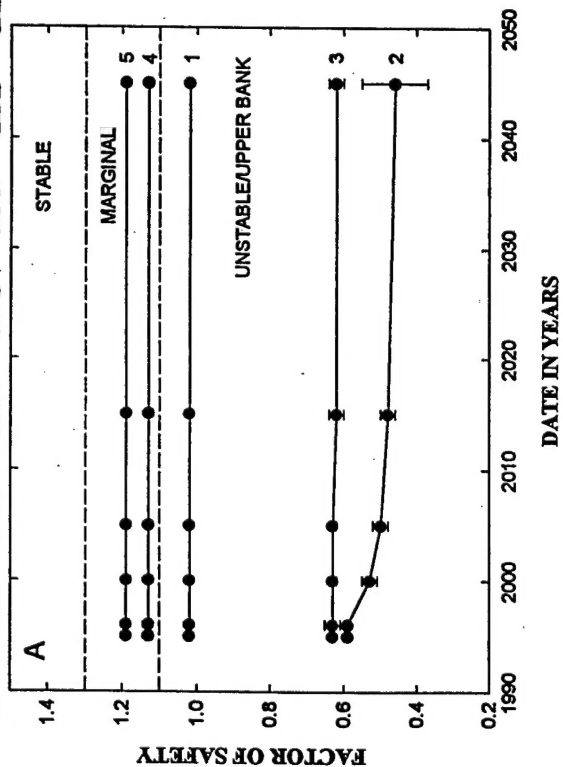
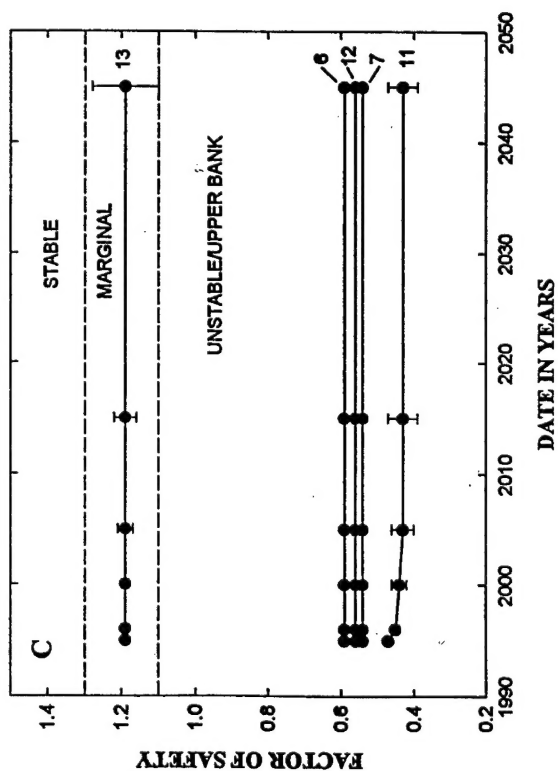
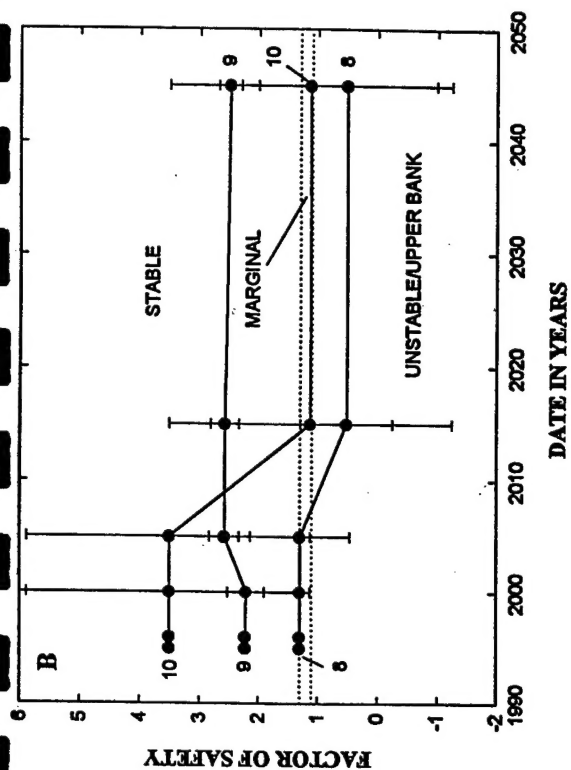
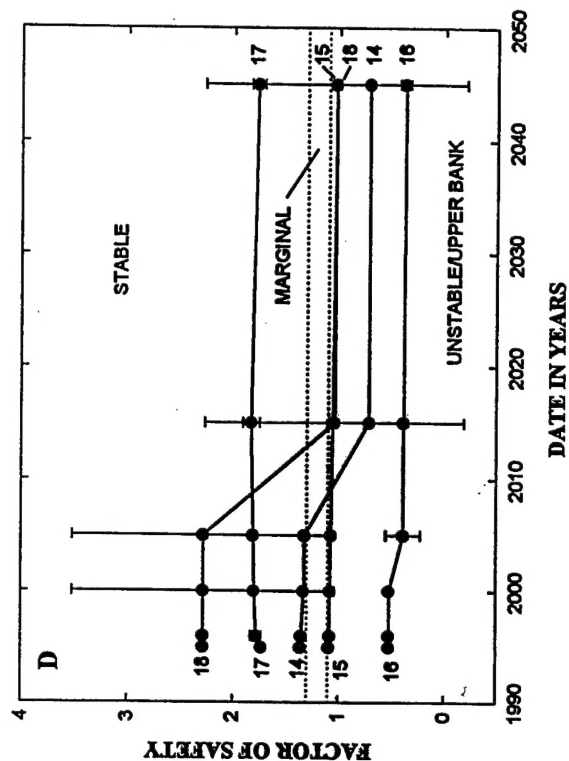
FIGURE 10

Figure 10. Predicted factor of safety values versus time for existing and proposed flow regimes. Numbers annotated on curves indicate study site numbers: (A) Study sites 1-5 (Fort Peck dam reach); (B) Study sites 8-10 (Fort Peck dam reach); (C) Study sites 6-7 and 11-13 (Fort Peck dam reach); (D) Study sites 14-18 (Garrison dam reach). Error bars indicate range of predicted factor of safety values, obtained using range of values of ΔZ and $\Delta W/2$ at 95% confidence interval (see Table 5).

One year into the simulation (1996), there are no significant differences between factors of safety for the flow regimes (Figure 10a). After five years (2000), differences in factor of safety become discernible (Figure 10b), but are still small. These differences are mostly insignificant because the predicted change is either insufficient to result in a shift in bank-stability classification, or because the predicted change occurs within a bank classification. Only at 2 (11%) of the 18 sites (sites 4 and 13, which are in the Fort Peck dam reach), do decreases in factor of safety result in a shift from "marginal" conditions under the existing flow regime to "unstable" conditions under the proposed flow regime (Table 10). On this basis, the short-term impact on bank stability with respect to mass failure of implementing the proposed flow regime is to modify the degree and type of instability rather than to increase the extent of instability along the study reaches.

Bank stability results at each successive date in the simulation are shown on Figure 10. The error bars on this figure reflect the uncertainty introduced into the factor of safety computations that results from using a range of values of ΔZ and $\Delta W/2$ in the bank simulation. After 50 years (2045), between 10 and 12 of the 18 study sites (56%-66%) are predicted to be subject to bank instability (Figure 10 and Table 10). These data compare with the observation that about 54% of contemporary (1995) banklines are subject to mass instability (Table 8). This indicates that the extent of bankline subject to mass bank failure will increase slightly over a 50-year period, under either the existing or proposed flow regimes.

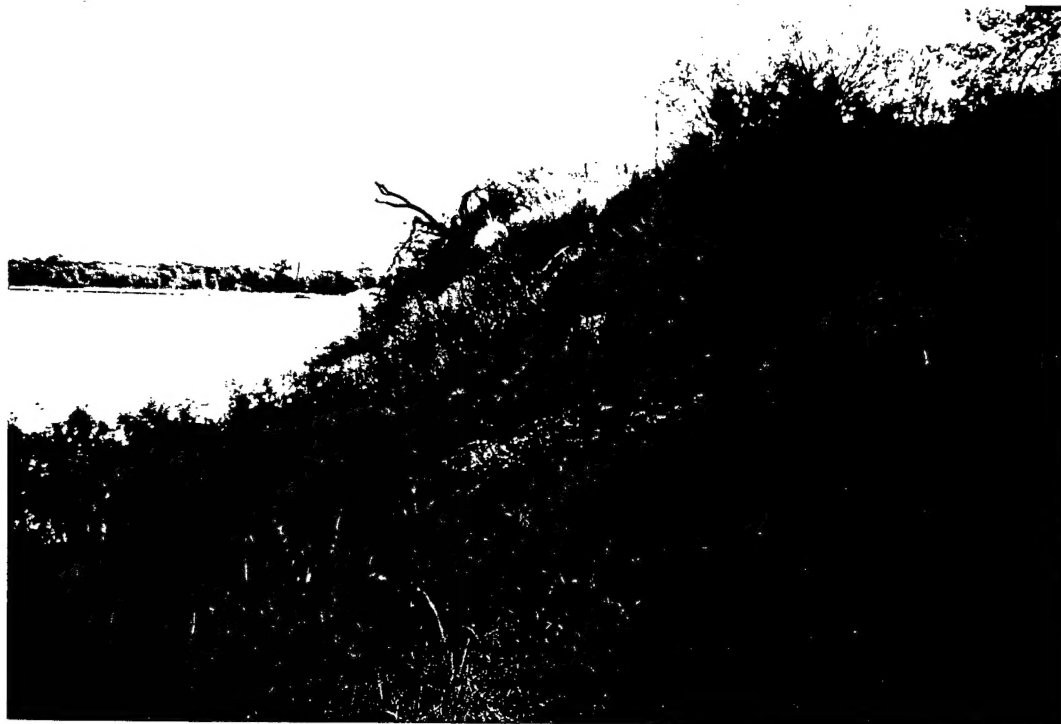
Plate 1c

(3) "Upper Bank" banks have simulated factors of safety less than 1.1 with failure planes confined to the upper half of the bank. Bankline retreat occurs through combinations of fluvial erosion and mass instability (Plate 1c). Rates of bank retreat in this category are frequently more severe than those in categories (1) and (2), but are usually less severe than those of category (4);

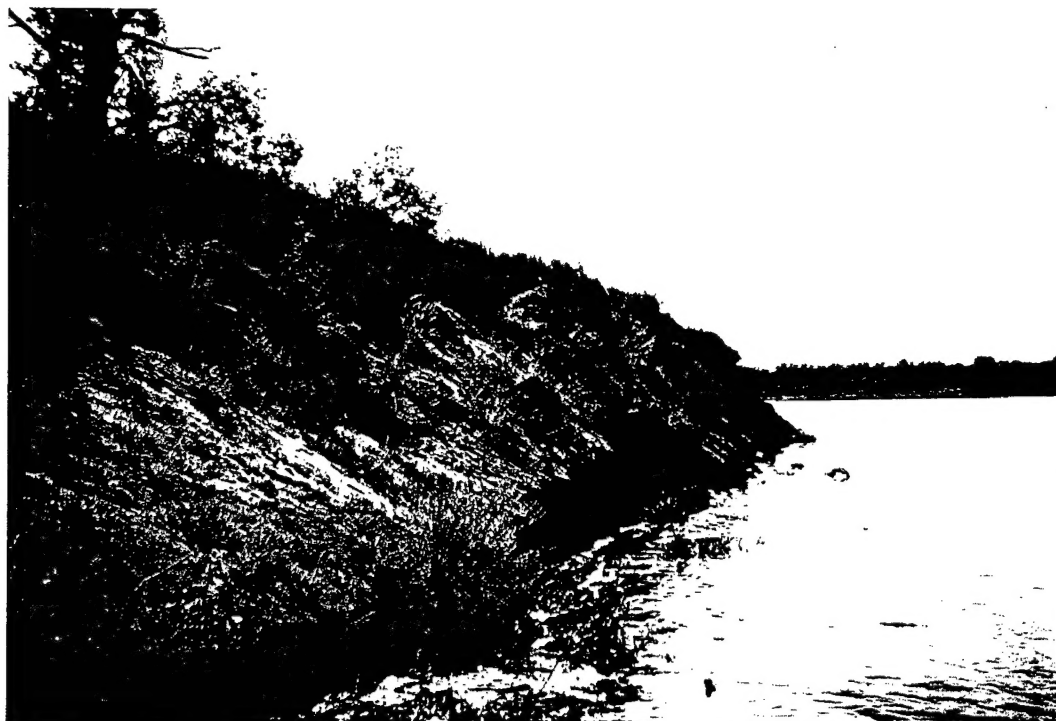
Plate 1d

(4) "Unstable" banks have simulated factors of safety less than 1.1 with failure planes intersecting the lower half of the bank profile (Plate 1d). Bankline retreat occurs through combinations of fluvial erosion and deep-seated mass instability. Rates of bank retreat in this category are commonly severe.

(A) Unstable bank at RM 1719.5. Unstable banks have predicted factors of safety less than 1.1, with failure planes close to the toe. Note notching at base due to fluvial bank erosion. (B) Upper bank failure at RM 1761.5. Upper bank failures have predicted factors of safety less than 1.1 and failure planes are close to the floodplain. (C) Marginal bank at RM 1689. Marginal banks have factors of safety in the range ($1.1 \leq FS \leq 1.3$) and are not presently subject to mass instability, but may have been in the past, or may become so in the future. (D) Stable bank at RM 1597. Stable banks have $FS > 1.3$. The dense vegetation cover and relatively low bank angle indicate stability with respect to mass failure, but the tilted structure in the background indicates bank retreat has occurred at this site in the past.
